**Flood Control Project Maintenance
Levee Inspections**
LMA District Cover Sheet
Spring 2020 Levee Inspection Results

Yolo County Service Area 6

Spring 2020 Levee Inspection Results

Waterway			Bank	Unit Miles
Unit No. 01 Right Bank of Sacramento River at Knights Landing			Right	5.87
	Spring (March - May)	Summer (June - August)	(September - November) Fall	Winter (December - February)
Unit Maintenance Rating (Fall Only)				
Date of Inspection	3/19/2020 - 3/19/2020			
DWR Inspector	Zach Jojola			
Accompanied By	Thomas Engler MBK

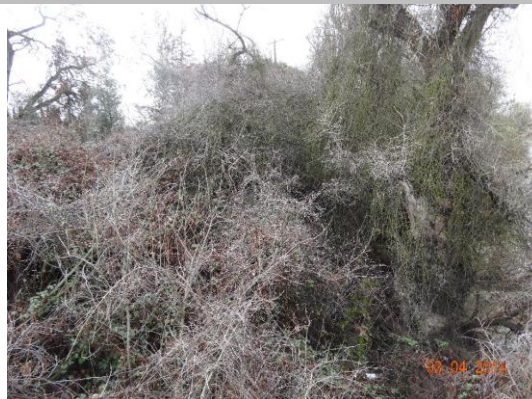
Photo 2 of 3 : UCIP_SP_2020_31904_58227.jpg

View of waterward toe photo taken from bridge.

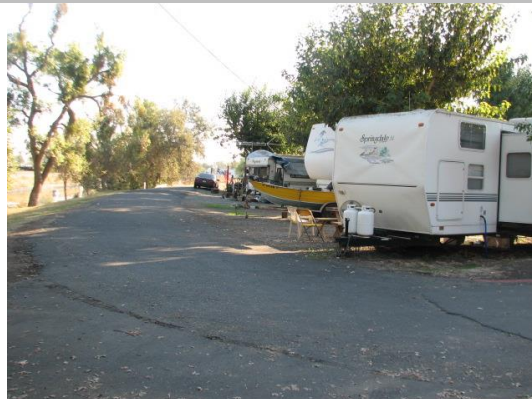
Photo 1 of 2 : SP_2020_NA0022_350_28_20200228_00012.jpg

LM Start	0.22	Rating **	M	Issue No.	28
LM End	0.25	Issue Type +	En	Location *	LS
Category	Earthen Levee			GPS Latitude/Longitude	
				Start	End
Item	Encroachments			38.801394 °	38.801613 °
				-121.721918 °	-121.721328 °
DWR ID	DWR_NA0022_01_s_2012_28				
Comment Code					
BU : Building					
Inspector Comment					
RV park runs on and along levee to bridge.

The RV park is encroached into the levee crown. Fall 2013

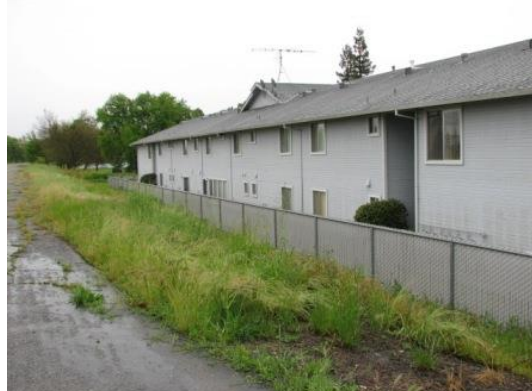
Photo 1 of 1 : SP_2020_NA0022_350_26_20200228_00011.jpg

LM Start	0.35	Rating **	U	Issue No.	26
LM End	0.39	Issue Type +	En	Location *	LS
Category	Earthen Levee			GPS Latitude/Longitude	
				Start	End
Item	Encroachments			38.801886 °	38.802020 °
				-121.719588 °	-121.718889 °
DWR ID	DWR_NA0022_01_f_2018_26				
Comment Code					
BU : Building					
Inspector Comment					
Apartments with chainlink fence with lathe woven into it is located on the landside toe.

The apartments and fence along the toe of the levee. Fall 2013

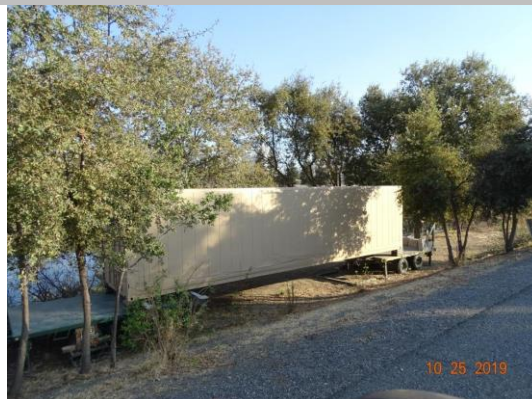
Photo 1 of 3 : SP_2020_NA0022_350_71_20200228_00032.jpg

LM Start	0.40	Rating **	U	Issue No.	71
LM End	0.40	Issue Type +	En	Location *	WS
Category	Earthen Levee			GPS Latitude/Longitude	
				Start	End
Item	Encroachments			38.802052 °	38.802052 °
				-121.718624 °	-121.718624 °
DWR ID	DWR_NA0022_01_f_2016_71				
Comment Code					
UR : Urban					
Inspector Comment					
Connex trailer on the waterside berm that appears to be a dwelling. This is a pending Board enforcement item under case 2019-15529.

View of the connex box on the waterside berm. Fall 2019.

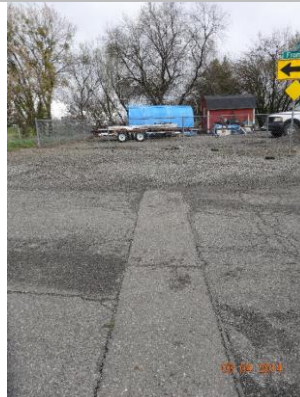
Photo 2 of 3 : UCIP_SP_2020_31627_57880.jpg

View of waterward side. Alignment is visible on paved road.

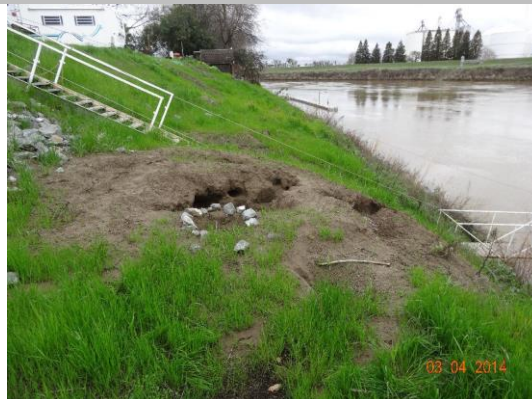
Photo 2 of 3 : UCIP_SP_2020_38188_69560.jpg

Comment Code					
Inspector Comment					
DS_ID:19519 FS_ID:38188 EP_NO: N/A Repair Type: Non-Urgent Crossing Status: Indicator Found UCIP Comments: Unable to find any signs of crossing on waterward side. Signs of concrete riser visible on landward side. If crossing is abandoned owner will need to coordinate with the Central Valley Flood Protection Board (CVFPB) for Title 23 requirements. FIELD_STRUCT_DESC: 10-inch pipe of an unknown material or purpose through the levee, 3.3 feet below the crown. 24-inch concrete riser on the landside (LS). Plate welded on the waterside (WS) end in 1975. [Additional Reference(s): DWR Levee Log, 2005]. FS Date: 3/4/2014

View of waterward slope. Large hole visible on waterward side.

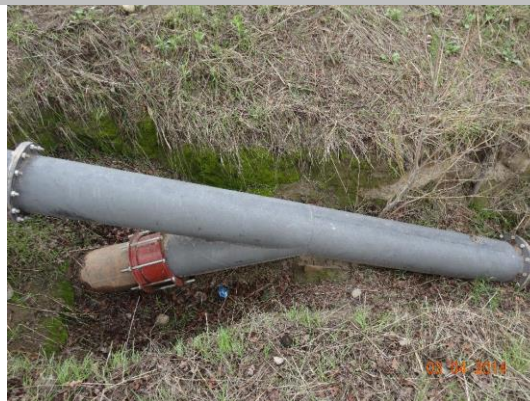
Photo 3 of 3 : UCIP_SP_2020_31969_58408.jpg

Comment Code					
Inspector Comment					
DS_ID:19540 FS_ID:31969 EP_NO: N/A Repair Type: Non-Urgent Crossing Status: Found UCIP Comments: Pipe section on waterward side appears to have been removed and reinstalled--Need to contact owner to obtain additional information regarding work completed. FIELD_STRUCT_DESC: 14-inch steel irrigation discharge pipe through the levee, 4.6 feet below the crown. Pump and valve on the riverbank. See DS_ID 19521. (Plans for installation of an angle mount low-lift pump and structure to replace an existing portable pumping plant, which will be connected to the existing 14-inch discharge pipe through the levee authorized under Permit No. 3798, 1961 - Alta Morris). [Additional Reference(s): USACE Sacramento O&M Manual 127, June 1953, (Station 266+72.2)]. FS Date: 3/4/2014

Pipe junction exposed on waterward side.

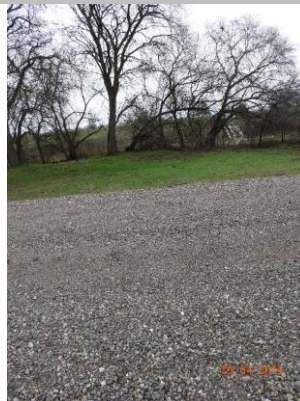
Photo 1 of 3 : UCIP_SP_2020_38190_69563.jpg

LM Start	1.75	Rating **	M	Issue No.	405	
LM End	1.75	Issue Type +	En	Location *		
Category	Supplemental			GPS Latitude/Longitude		
				Start	End	
Item	DWR UCIP Field Study			38.797928 °	38.797928 °	
				-121.697992 °	-121.697992 °	
DWR ID	19539					
Comment Code						
Inspector Comment						
DS_ID:19539						
FS_ID:38190						
EP_NO: N/A						
Repair Type: Non-Urgent						
Crossing Status: Indicator Found						
UCIP Comments: Need to contact owner to determine status of crossing.						
FIELD_STRUCT_DESC: *ABANDONED* 12-inch corrugated metal irrigation discharge pipe through the levee, at an unknown depth. Gate valve in pump house on the waterside (WS), no pump house found.						
Crossing was abandoned prior to 1968. [Additional Reference(s): USACE Sacramento O&M Manual 127, June 1953, (Station 224+3.5), 18-inch pipe referenced].						
FS Date: 3/4/2014

View of waterward side.

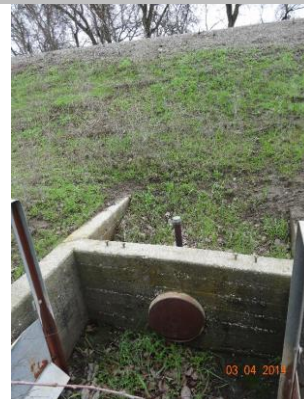
Photo 3 of 3 : UCIP_SP_2020_38190_69564.jpg

Concrete box located on landward toe.

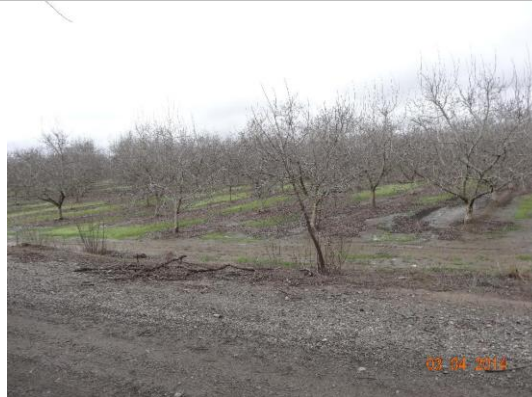
Photo 1 of 3 : UCIP_SP_2020_40536_58265.jpg

Comment Code						
Inspector Comment						
DS_ID:19524 FS_ID:40536 EP_NO: 9413 Repair Type: Non-Urgent Crossing Status: Found UCIP Comments: Alignment through levee unknown--no signs of crossing through landward side. Need to contact owner to determine status of crossing. This crossing appears to have been updated since 1970s. FIELD_STRUCT_DESC: 24-inch pipe of an unknown material or purpose through the levee, 15.5 feet below the crown. Gate valve on the landside (LS) end. Ramp on the waterside (WS) slope. (Retention of a 30-inch pipe through the levee and a slide gate in a corrugated metal pipe [CMP] riser on both slopes authorized under Automatic Board Order (ABO) issued as Permit No. 9413, 1974 - Wallace Construction Company). Added appurtenances noticed in 2014: pump, metal frame platform, flow meter, and control panel on the WS. Appurtenances could be associated with Permit No. 12804. This appears to be the same entry as DS_ID 19538. [Additional Reference(s): DWR Levee Log, 2005]. FS Date: 3/4/2014

View of landward side.

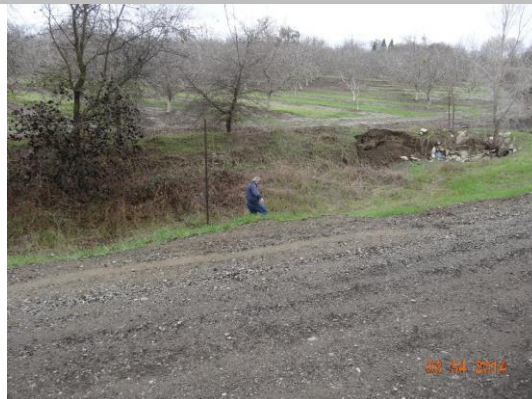
Photo 3 of 3 : UCIP_SP_2020_31915_58272.jpg

View of landward side.

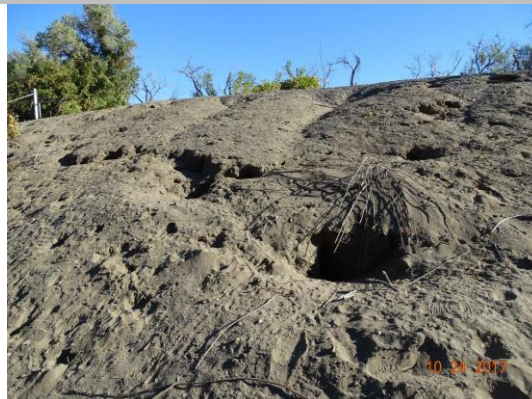
Photo 2 of 2 : SP_2020_NA0022_350_8_20200228_00004.jpg

View of rodent holes on landside slope. Fall 2017.

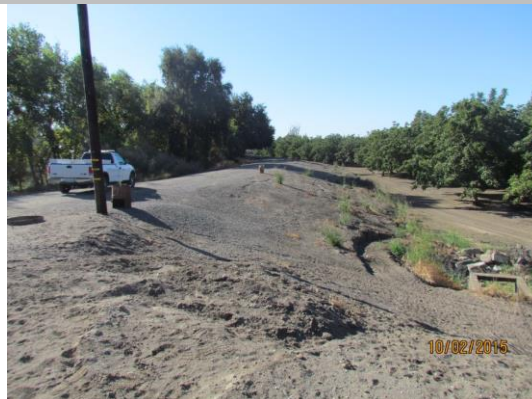
Photo 2 of 4 : SP_2020_NA0022_350_96_20200228_00043.jpg

Perspective view of the erosion around the pipe on the landward side of the levee looking downstream. Fall 2015.

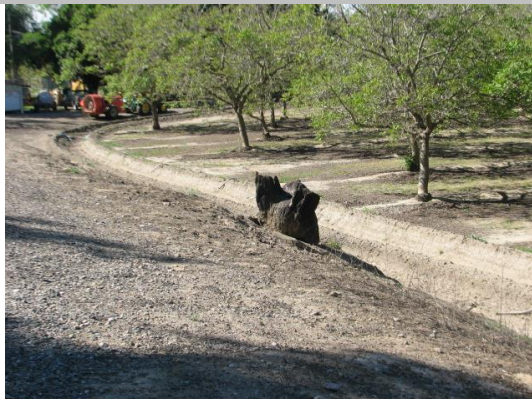
Photo 1 of 1 : SP_2020_NA0022_350_37_20200228_00018.jpg

LM Start	2.52	Rating **	U	Issue No.	37
LM End	2.52	Issue Type +	Ma	Location *	LS
Category	Earthen Levee			GPS Latitude/Longitude	
				Start	End
Item	Trim / Thin Trees			38.787778 °	38.787778 °
				-121.694296 °	-121.694296 °
DWR ID	DWR_NA0022_01_s_2014_37				
Comment Code					
T5 : Tree stumps.					
Inspector Comment

Tree stump decomposing and may pose a risk to the levee. Spring 2014

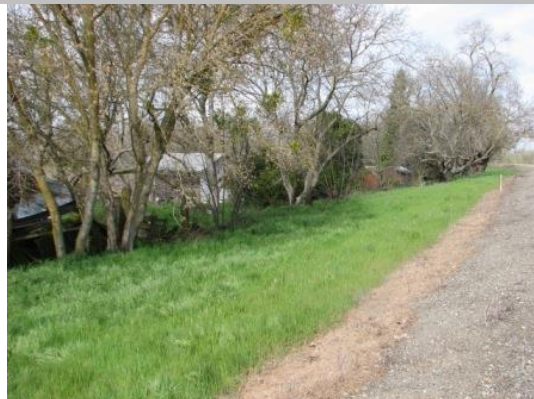
Photo 2 of 2 : SP_2020_NA0022_350_12_20200228_00007.jpg

The buildings are encroaching into the levee slope.

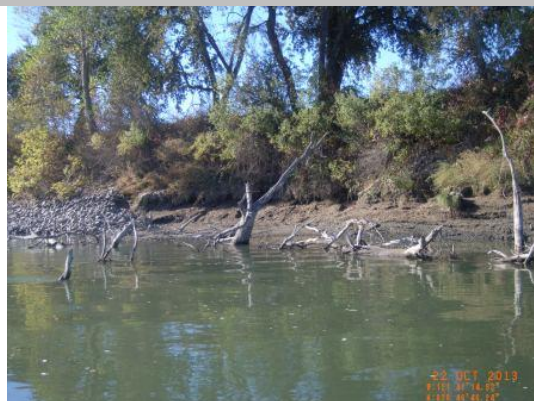
Photo 1 of 1 : SP_2020_NA0022_350_48_20200228_00025.jpg

2017 Site ID: SAC 86.9 R
 Status: Eroding
 2017 Field Notes: No observed change..
 Site History: 2006 - Short section is into the levee toe, rest is near the levee toe. Mass failure and fluvial erosion of depositional material. Rock at the upstream and downstream ends. 2011 - Minor new erosion. 2012 - Slope continues to steepen, tree roots have become exposed, and new eddy formed.

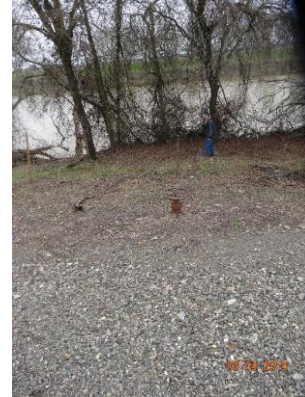
Photo 1 of 3 : UCIP_SP_2020_39858_71841.jpg

View of waterward side.

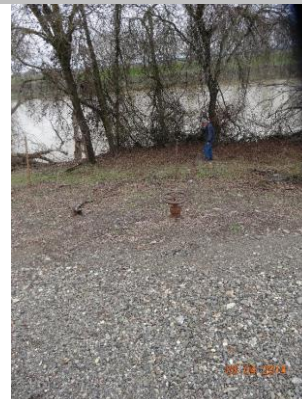
Photo 2 of 3 : UCIP_SP_2020_31916_58274.jpg

View of waterward side.

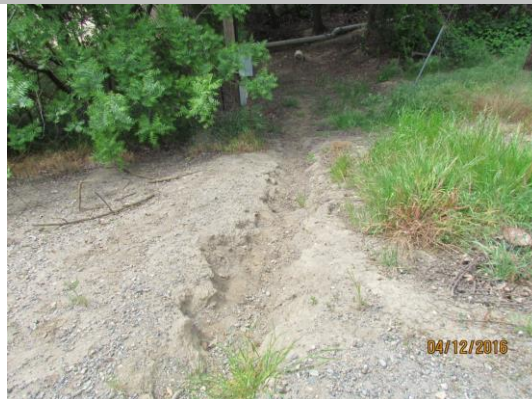
Photo 2 of 3 : SP_2020_NA0022_350_79_20200228_00036.jpg

View of erosion on the landside slope. Spring 2016.

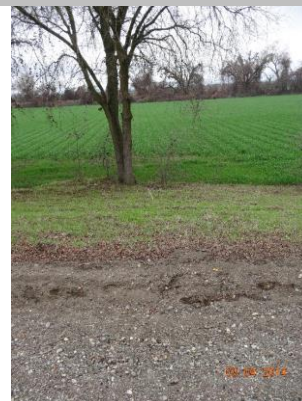
Photo 1 of 3 : UCIP_SP_2020_38996_69568.jpg

View of landward side.

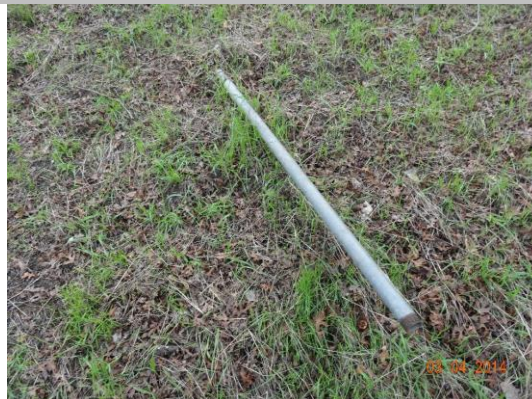
Photo 3 of 3 : UCIP_SP_2020_38996_69566.jpg

Abandoned conduit line through levee.

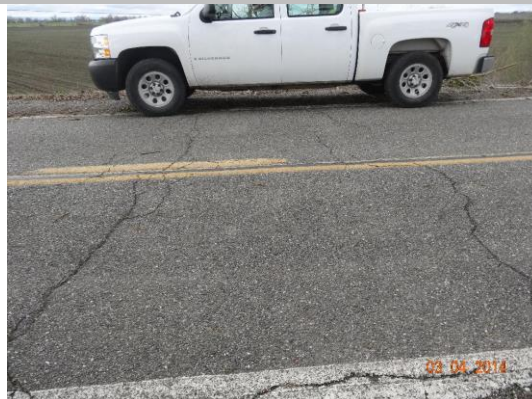
Photo 3 of 3 : UCIP_SP_2020_38999_57946.jpg

View of levee crown at crossing.

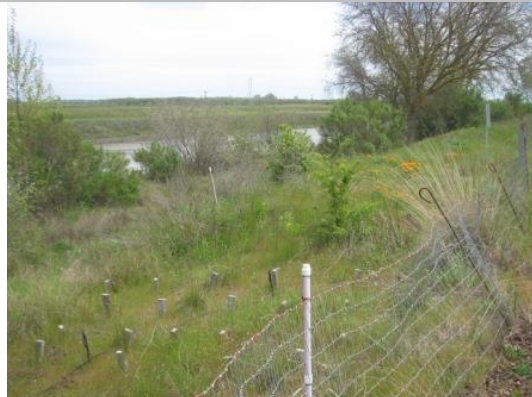
Photo 2 of 2 : SP_2020_NA0022_350_36_20200228_00017.jpg

LM Start	4.25	Rating **	A/W	Issue No.	36 (cont)
LM End	4.49	Issue Type +	Ob	Location *	WS
Category	Earthen Levee			GPS Latitude/Longitude	
				Start	End
Item	Vegetation			38.767125 °	38.764582 °
				-121.693267 °	-121.690285 °
DWR ID	DWR_NA0022_01_s_2020_36

Fence, irrigation and stakes in the revegetation site.

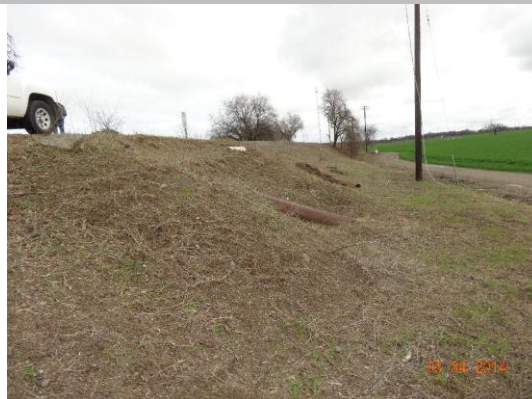
Photo 1 of 3 : UCIP_SP_2020_31986_58442.jpg

Comment Code						
Inspector Comment						
DS_ID:19530 FS_ID:31986 EP_NO: 9409 Repair Type: Non-Urgent Crossing Status: Found UCIP Comments: Pump station not found. Crossing appears to be abandon. Need to contact owner to determine status. Repair site on waterward side--waterward slope revegetated. FIELD_STRUCT_DESC: 16-inch steel irrigation discharge pipe through the levee, 6.4 feet below the crown. Pump and control valve on the riverbank. Ramp on the landside (LS) slope. (Retention of a 16-inch pipe through the levee and a pump on the riverbank authorized under Automatic Board Order (ABO) issued as Permit No. 9409, 1974 - Clayton Russell). [Additional Reference(s): DWR Levee Log, 2005]. FS Date: 3/4/2014

LM Start	4.44	Rating **	M	Issue No.	415 (cont)
LM End	4.44	Issue Type +	En	Location *

View of landward side.

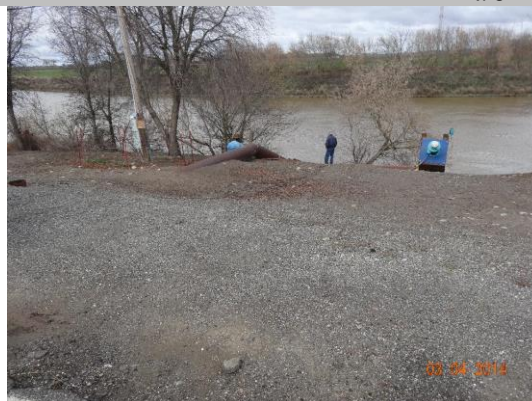
Photo 2 of 3 : UCIP_SP_2020_52729_58455.jpg

DS_ID:19531
FS_ID:52729
EP_NO: 9408
Repair Type: Urgent
Crossing Status: Found
UCIP Comments: 07/17/2018 No change from previous inspection. Patch repair of pavement on levee crown is in the same condition. Good candidate for internal inspection. (O.Yakimov-DWR UCIP)10/24/2017 Received updated photos from DWR levee inspector, Z. Jojola, and the photos show some depression along LS slope. Road patch repair is still visible on levee road, recommend an internal integrity inspection of pipe to determine the condition through the levee and slopes. (DWR UCIP - O. Magana) 07/13/2016 Same as last inspection. Sink hole repair visible on levee road. Recommend contacting owner to determine if an internal integrity inspection of the pipe was completed to confirm sink hole was not the cause of the damage to road. If no internal integrity inspection was completed during road repair, recommend an internal integrity inspection be completed at this location based on the sink hole that developed along pipe alignment and based on age of pipe. (DWR UCIP - omagana)03/04/2014 Signs of sink hole repair on levee crown. Owner will need to contact CVFPB to address sink hole repair. (DWR UCIP - omagana)

LM Start	4.69	Rating **	U	Issue No.	417 (cont)
LM End	4.69	Issue Type +	En	Location *	
Category	Supplemental			GPS Latitude/Longitude	
				Start	End
Item	DWR UCIP Field Study			38.763087 °	38.763087 °
				-121.687125 °	-121.687125 °
DWR ID	19531

View of WS.

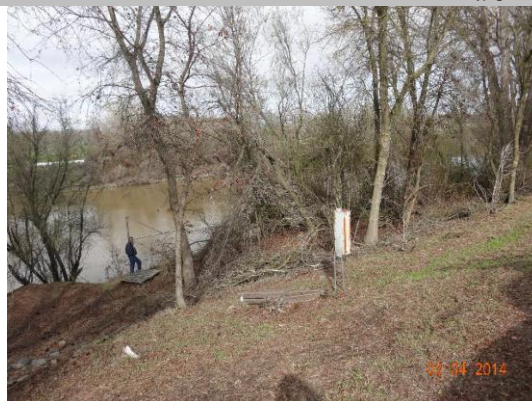
Photo 1 of 3 : UCIP_SP_2020_31927_58332.jpg

LM Start	5.47	Rating **	M	Issue No.	418 (cont)
LM End	5.47	Issue Type +	En	Location *

View of waterward side.

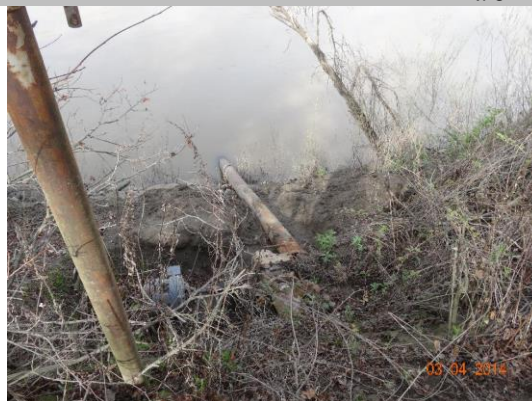
Photo 3 of 3 : UCIP_SP_2020_31927_58335.jpg

LM Start	5.47	Rating **	M	Issue No.	418 (cont)
LM End	5.47	Issue Type +	En	Location *	
Category	Supplemental			GPS Latitude/Longitude	
				Start	End
Item	DWR UCIP Field Study			38.759678 °	38.759678 °
				-121.674492 °	-121.674492 °
DWR ID	19532

Pipe visible on waterward toe.

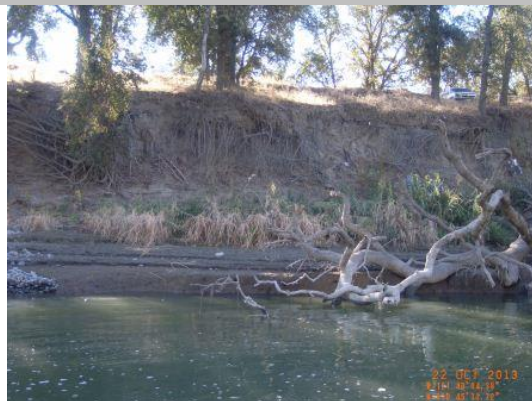
Photo 1 of 3 : SP_2020_NA0022_350_46_20200228_00022.jpg

Comment Code					
Inspector Comment					
2017 Site ID: SAC 83.9 R					
Status: Eroding					
2017 Field Notes: Fresh erosion on lower bank.					
Site History: 2006 - Approximately 18 to 20 ft of bank near levee at the corner of the levee and the Freemont Weir. Vertical bank with undercutting/mass failure. 2007 - Staked at top of bank for monitoring.					
2011 - Site has become significantly worse with more of the toe and lower bank eroded. Many trees have fallen since last year. 2012 - Site looks worse with more ersion around trees. 2013 - Additional erosion into the toe. 2015 - Site extended upstream about 500 ft to account for eroding bank. 2016 - Site continues to erode. Multiple trees appear ready to fall into the river.

USACE 2013 Photo #1

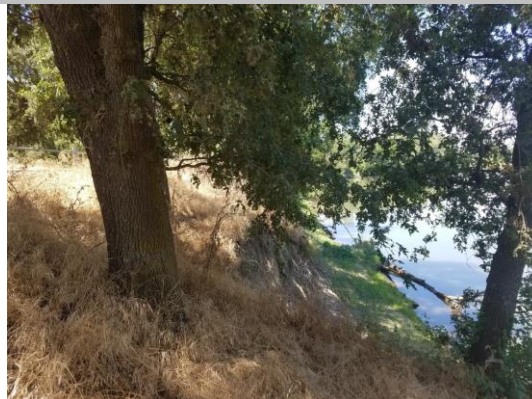
Photo 1 of 1 : LEVAL_SP_2020_490_4925.jpg

LM Start	5.85	Rating **	M	Issue No.	57
LM End	5.85	Issue Type +	Ma	Location *	WS
Category	Earthen Levee			GPS Latitude/Longitude	
				Start	End
Item	Erosion / Bank Caving			38.759100 °	38.759100 °
				-121.667960 °	-121.667964 °
DWR ID	LMA-328				
Comment Code					
E2 : Schedule repair of erosion site prior to the next inspection.					
Inspector Comment					
Large overbuilt levee section around a river bend. Erosion is progressing at a consistent rate due to the bend and a vertical wall is now exposed. Recommend repairing.					
Site ID No:490					
Site Designation:LMA-328
